From: OCARS_Pro@uncc.org
Sent: Friday, April 22, 2005 1:15 PM
To: Meagan Redfern
Subject: UNCC EMLCFM 2005/04/22 #00143 B0018165-00B NORM NEW

Property ID:	124
Property Address:	3233 Gilpin St.
Owner:	Michael & Terry Willis
Phone:	719-282-3683

This spreadsheet performs screening level calculations to estimate the effect of peeling leaded paint on the average concentration of lead in yard soil
3233 Gilpin Street

Property ID # 124 / 3233 Gilpin Street

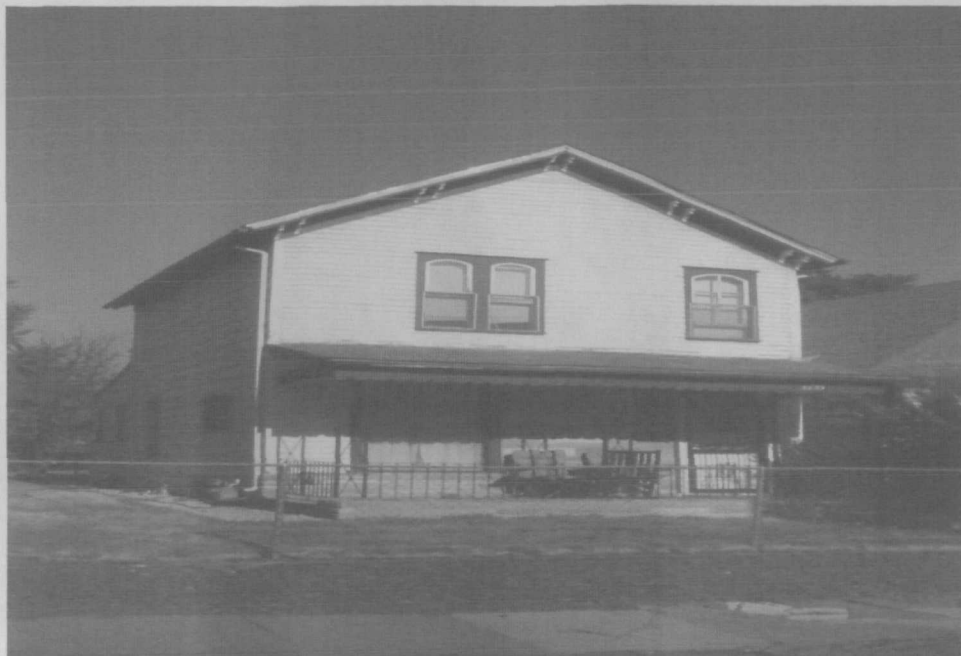
East exposure / porch of house

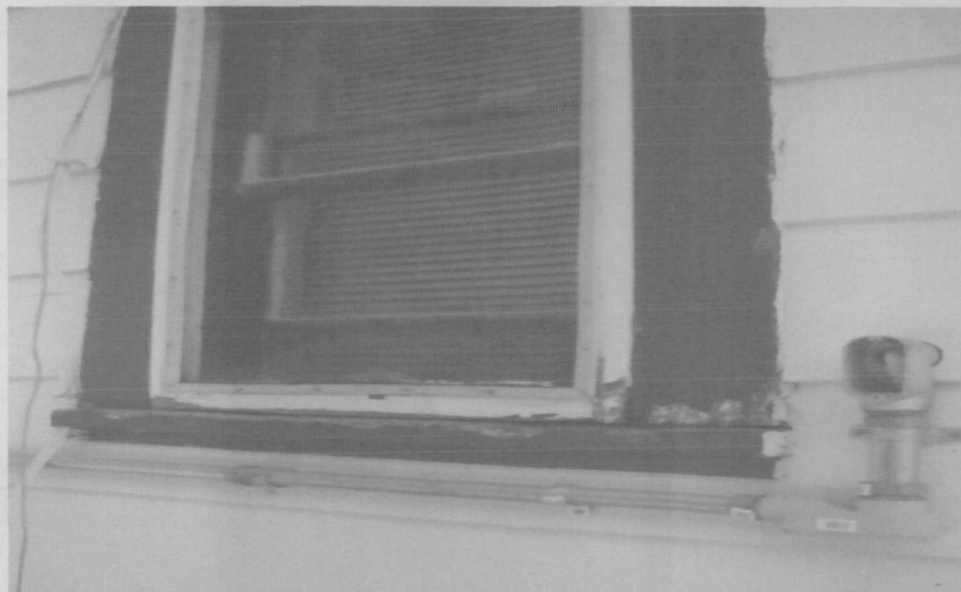
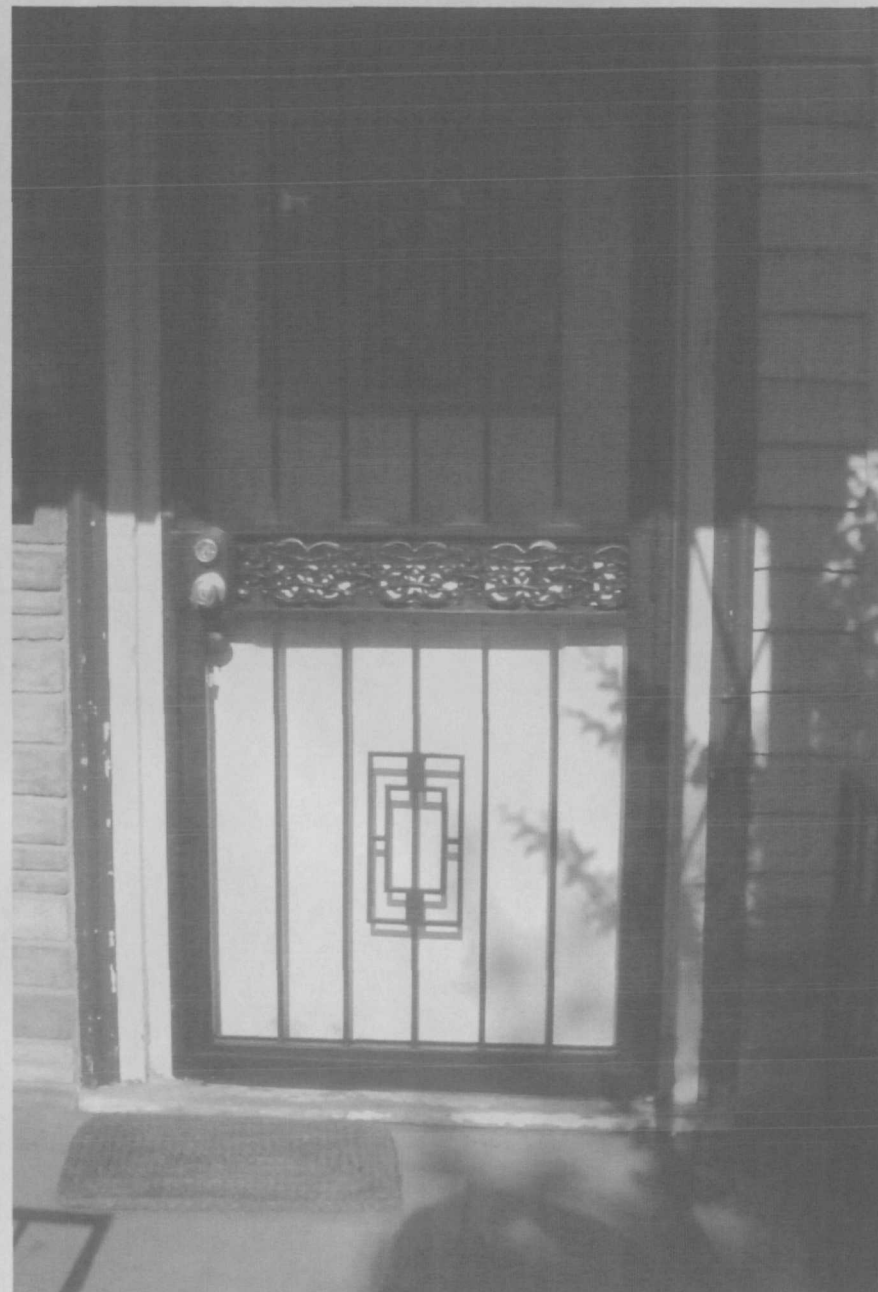
Red wood window sills on south exposure contain peeling lead paint White wood door trim on east porch contains peeling lead paint

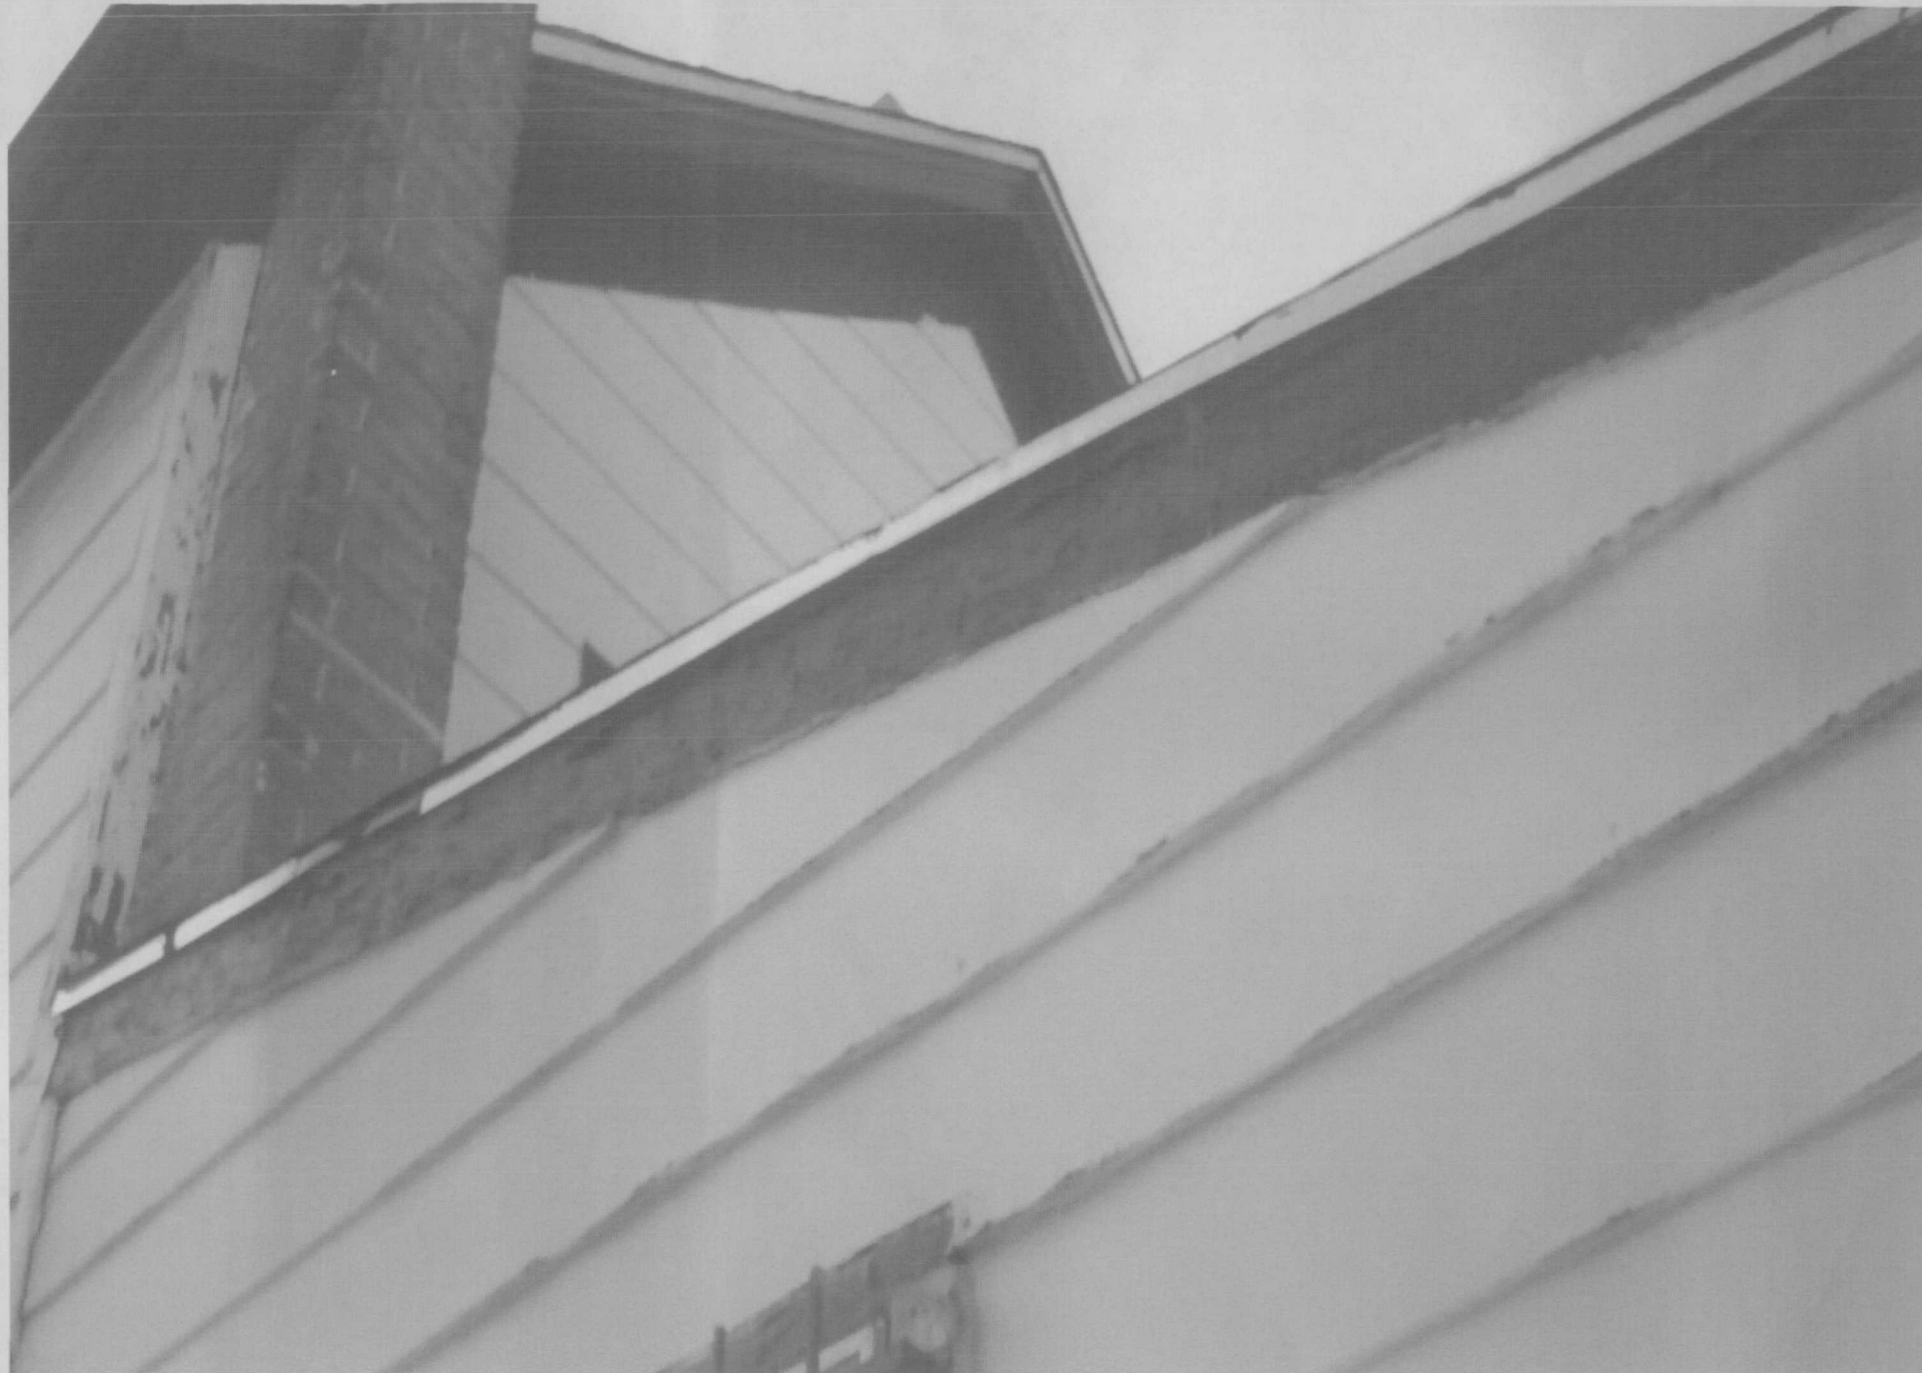
Property # 124: Peeling lead paint on red & white wood trim boards on north exposure of house

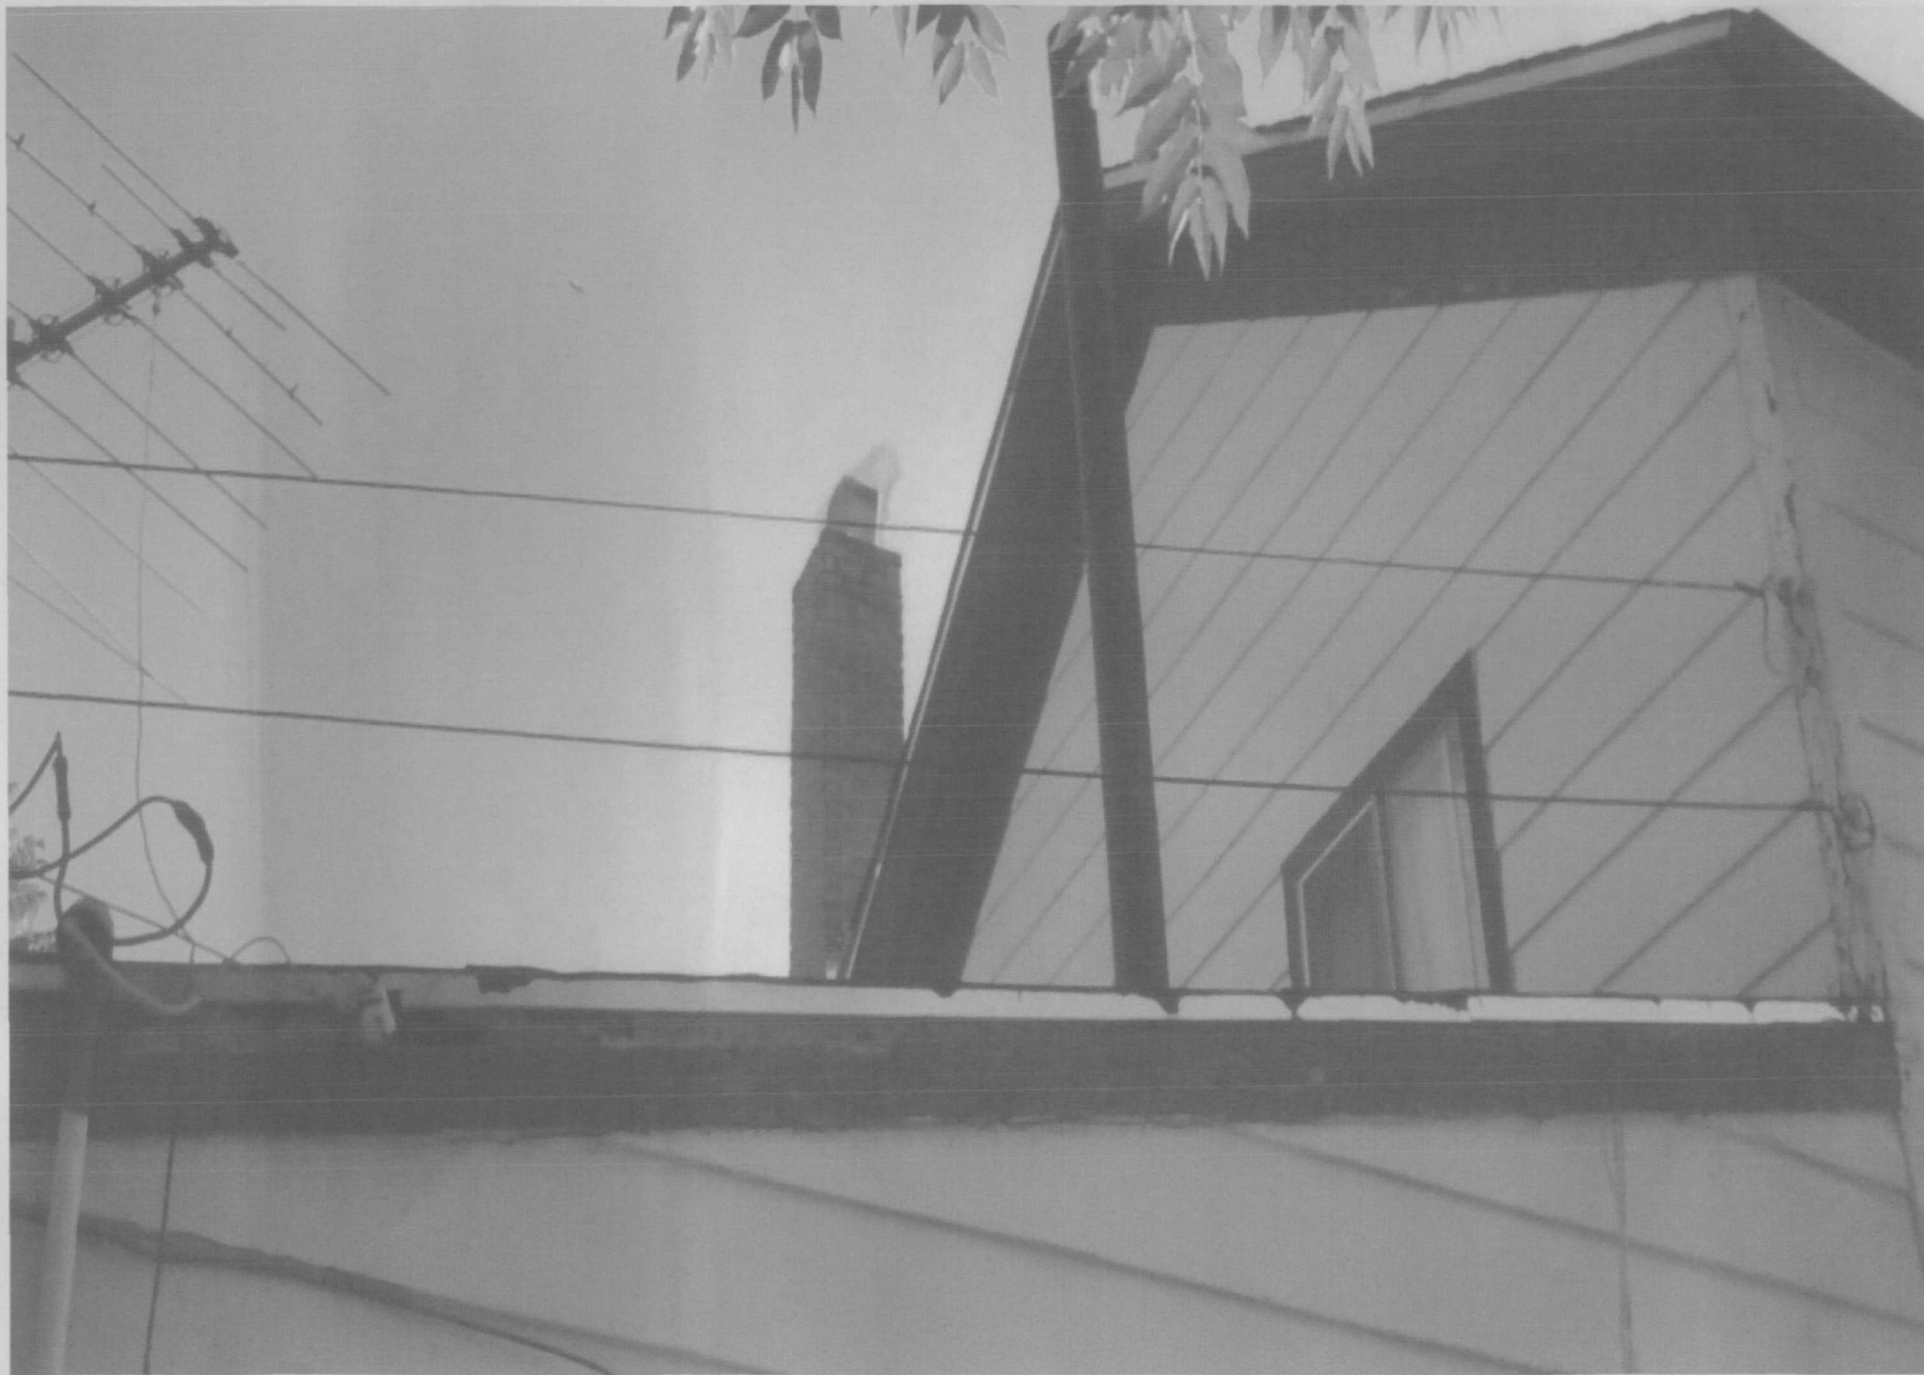
Property # 124: Peeling lead paint on red & white wood trim boards on south exposure of house

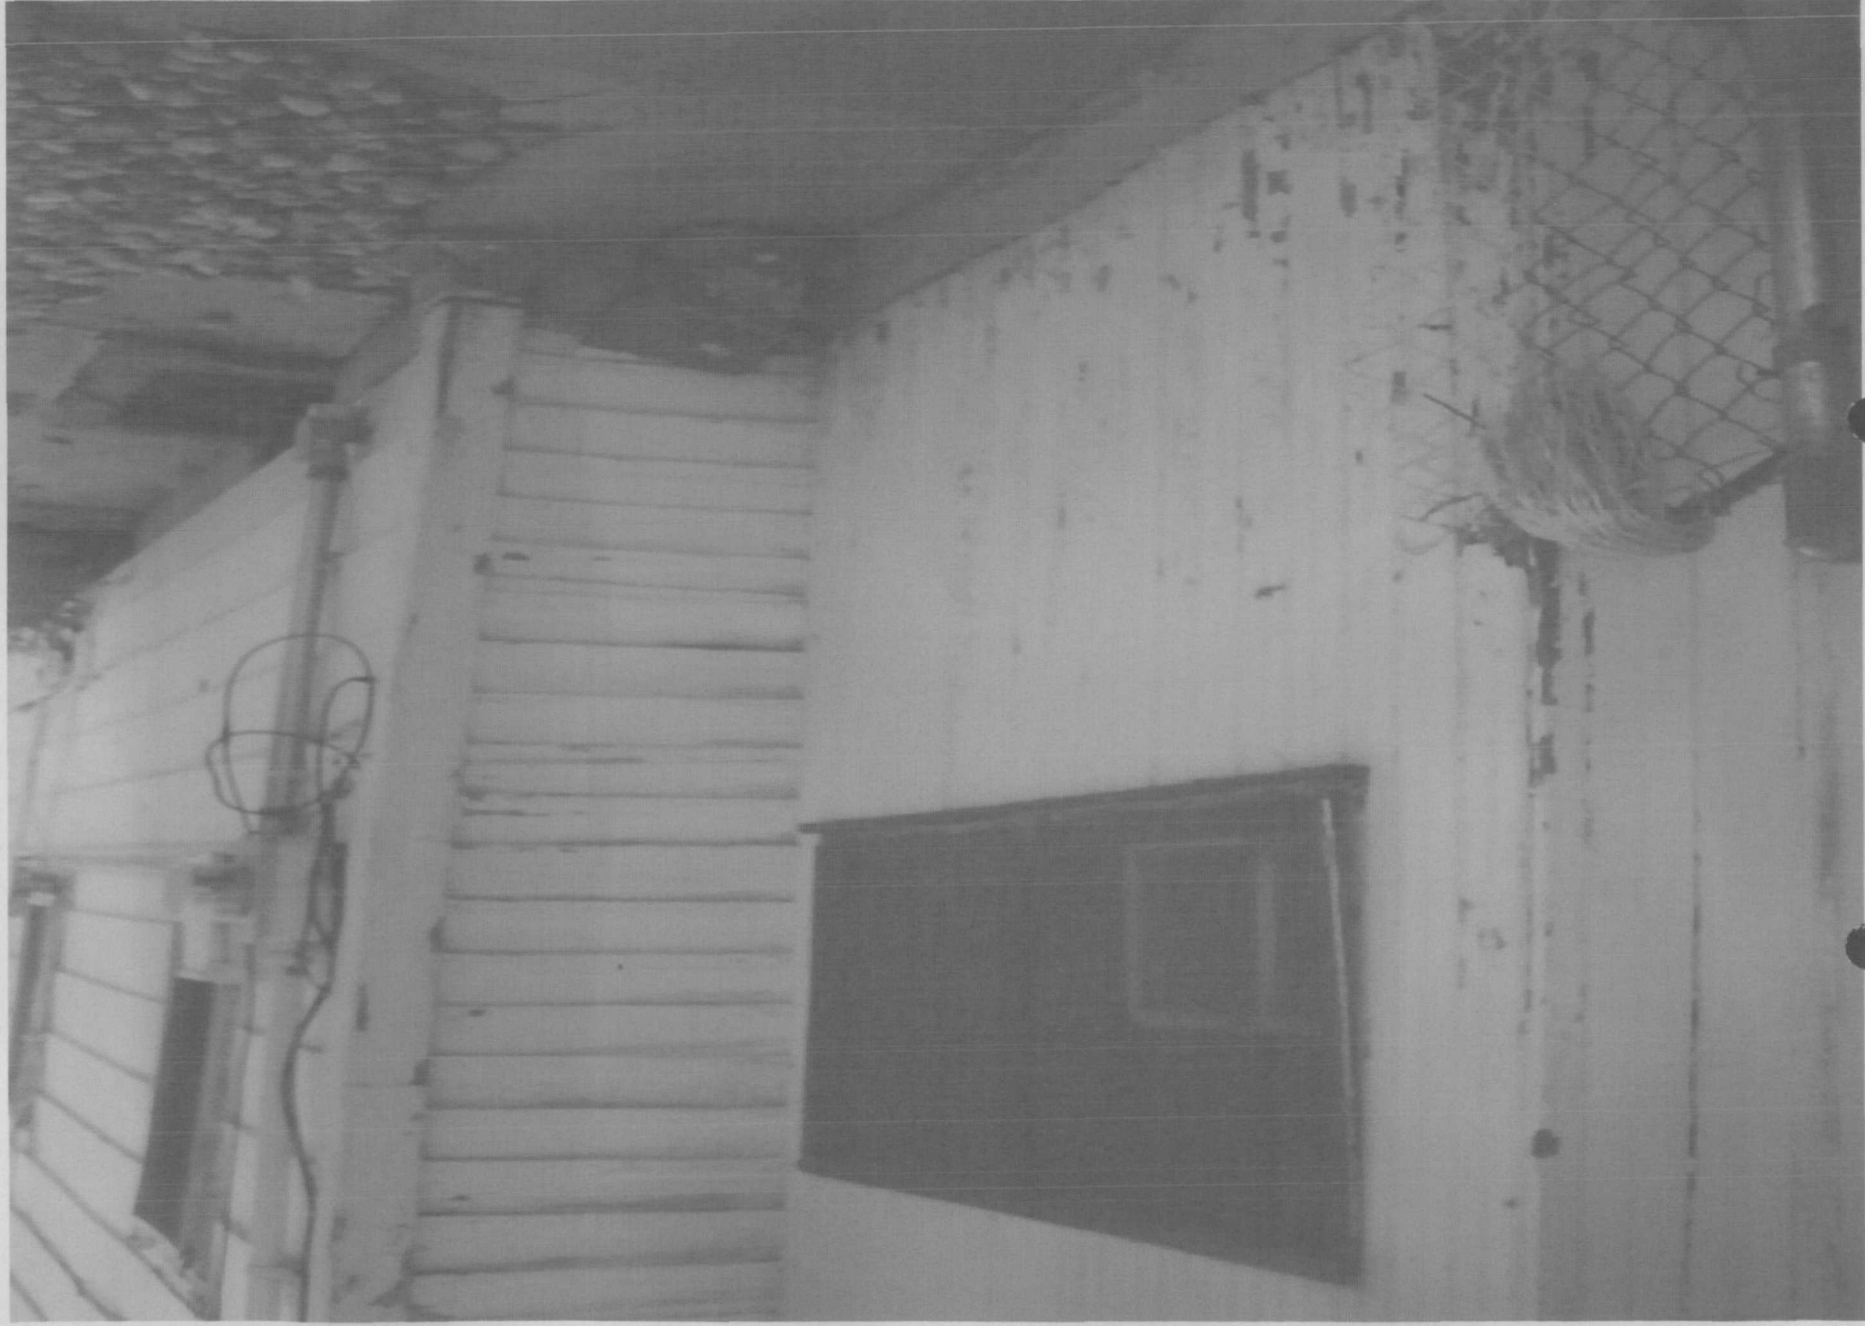
WHITE WOOD SIDING ON SOUTHWEST CORNER OF HOUSE CONTAINS PEELING LEAD PAINT

Property # 124: White wood siding on southwest corner of house contains peeling lead paint
